Contract #: 04-0120F4Cty: SF/ALA Rte: 80 PM: 13.2/13.9File #: 69.28**WELDING INSPECTION REPORT****Resident Engineer:** Pursell, Gary**Address:** 333 Burma Road**City:** Oakland, CA 94607**Report No:** WIR-002646**Date Inspected:** 14-May-2008**Project Name:** SAS Superstructure**OSM Arrival Time:** 630**Prime Contractor:** American Bridge/Fluor Enterprises, a JV**OSM Departure Time:** 1530**Contractor:** Zhenhua Port Machinery Company, Ltd (ZPMC), Changxing Island **Location:** Shanghai, China**CWI Name:** See below**CWI Present:** Yes No**Inspected CWI report:** Yes No N/A**Rod Oven in Use:** Yes No N/A**Electrode to specification:** Yes No N/A**Weld Procedures Followed:** Yes No N/A**Qualified Welders:** Yes No N/A**Verified Joint Fit-up:** Yes No N/A**Approved Drawings:** Yes No N/A**Approved WPS:** Yes No N/A**Delayed / Cancelled:** Yes No N/A**Bridge No:** 34-0006**Component:** OBG/Tower**Summary of Items Observed:**

OBG/Tower Sub Assembly**Bay 1 – PMT/Deck Panel Production**

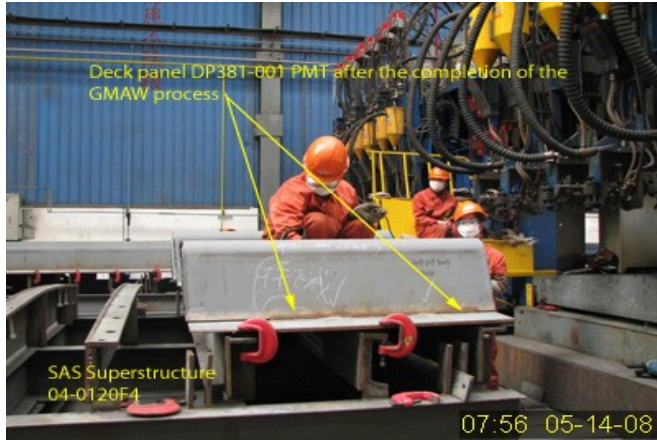
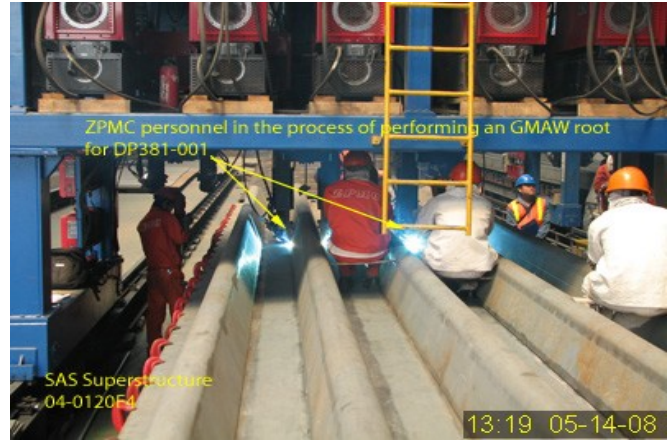
The QA inspector performed visual weld inspection to the deck panels deck panel DP490-001 welds 1 thru 6 and DP554-001 welds 6 thru 10. The QA inspector found weld discontinuities on all of the weld identified as incomplete fusion, overlap, under fill, undercut, oversize and undersize welds. Deck Panel DP490-001 and

DP085-001 had been visual inspected by ZPMC and ABF. A hand written visual inspection report was generated on this date with all the findings.

The following digital photograph below illustrates observation of the activities being performed.
